**Flood Control Project Maintenance
Levee Inspections**

Fall 2013 Levee Maintenance Deficiency Summary Report

Yolo County Service Area 6

Waterway	Bank	Unit Miles
Unit No. 01 Right Bank of Sacramento River at Knights Landing	Right	5.97

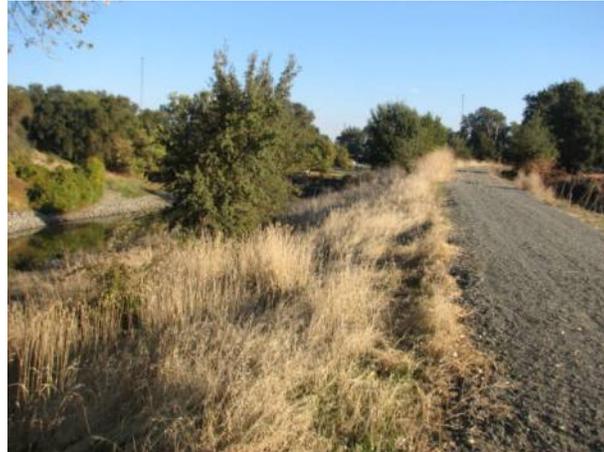
Levee Mile Report Line	4
Start Levee Mile	0.00
End Levee Mile	0.20
Location	Water Side
Category	Earthen Levee
Item	Vegetation
The vegetation partially blocks visibility. Fall 2013	
johngw_f_20131028_250.JPG

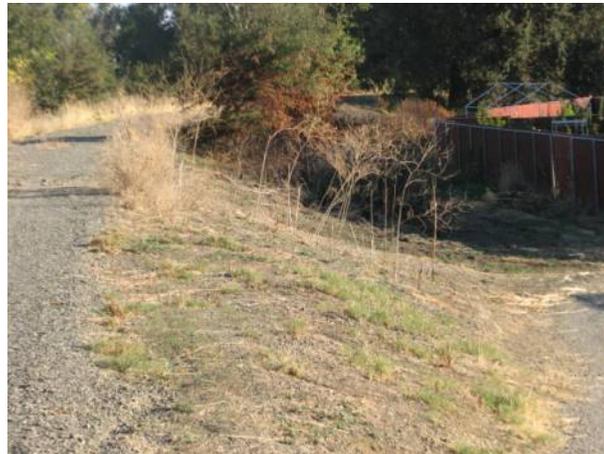
Levee Mile Report Line	5
Start Levee Mile	0.00
End Levee Mile	0.20
Location	Land Side
Category	Earthen Levee
Item	Vegetation
The vegetation complies with standards. Fall 2013	
johngw_f_20131028_251.JPG

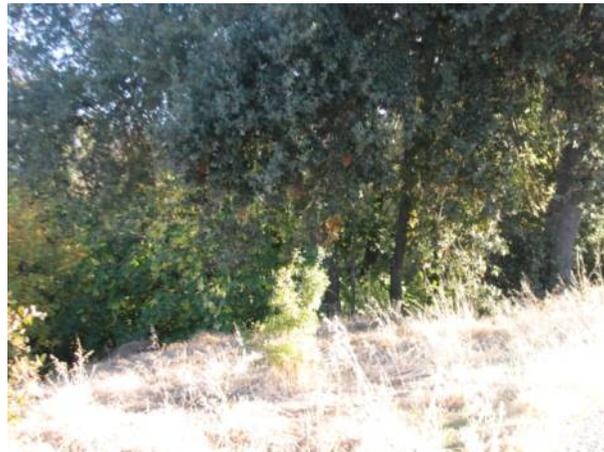
Levee Mile Report Line	6
Start Levee Mile	0.03
End Levee Mile	0.20
Location	Water Side
Category	Earthen Levee
Item	Vegetation
Tall vegetation, trees and brush block visibility. Fall 2013	
johngw_f_20131028_252.JPG

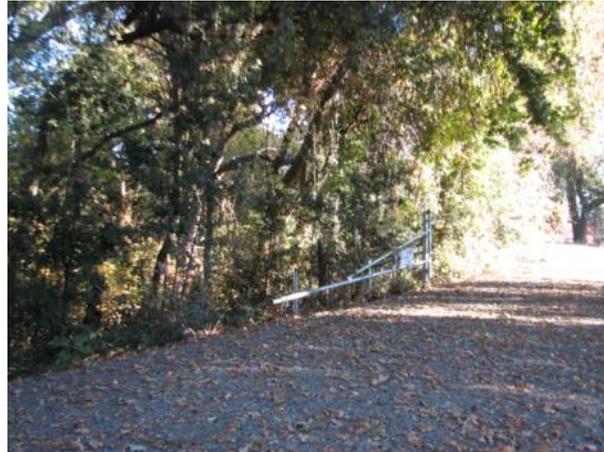
Levee Mile Report Line	6
Start Levee Mile	0.03
End Levee Mile	0.20
Location	Water Side
Category	Earthen Levee
Item	Vegetation
Trees and brush block visibility. Fall 2013	
johngw_f_20131028_253.JPG

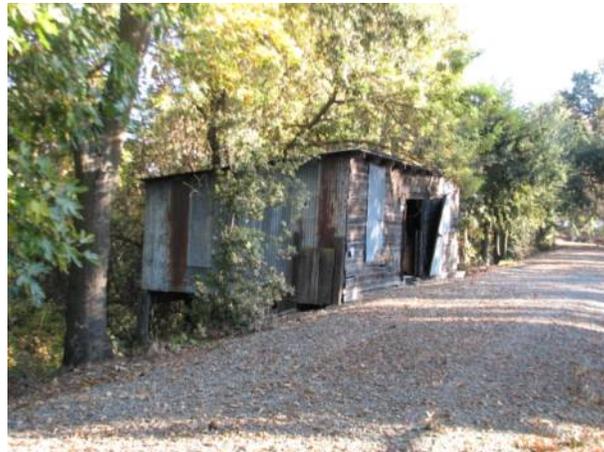
Levee Mile Report Line	7
Start Levee Mile	0.15
End Levee Mile	0.15
Location	Water Side
Category	Earthen Levee
Item	Encroachments
The old barn is on the waterside of the levee. Fall 2013	
johngw_f_20131028_254.JPG

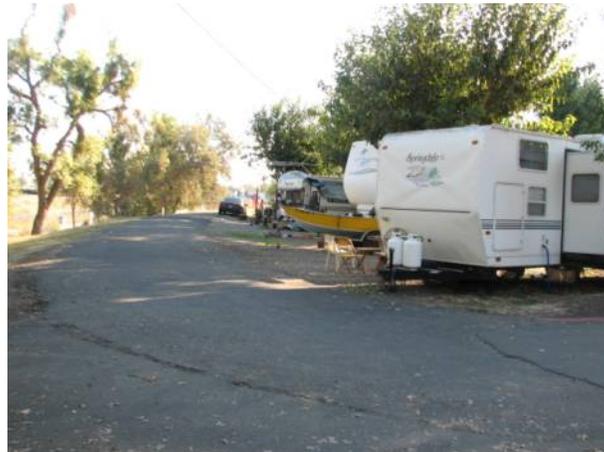
Levee Mile Report Line	9
Start Levee Mile	0.22
End Levee Mile	0.26
Location	Land Side
Category	Earthen Levee
Item	Encroachments
The RV park is encroached into the levee crown. Fall 2013	
johngw_f_20131028_255.JPG

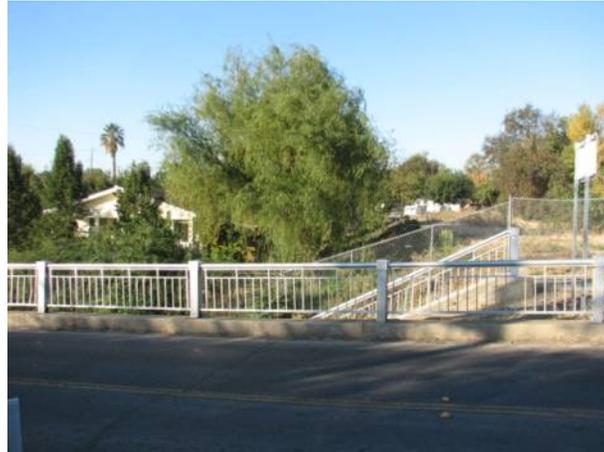
Levee Mile Report Line	10
Start Levee Mile	0.31
End Levee Mile	0.33
Location	Land Side
Category	Earthen Levee
Item	Vegetation
Landscaping is encroach into the levee easement. Fall 2013	
johngw_f_20131028_256.JPG

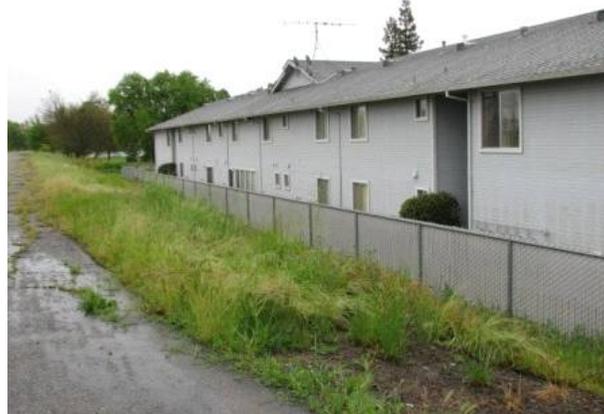
Levee Mile Report Line	11
Start Levee Mile	0.35
End Levee Mile	0.39
Location	Land Side
Category	Earthen Levee
Item	Encroachments
The apartments and fence along the toe of the levee. Fall 2013	
johngw_f_20131021_041.jpg

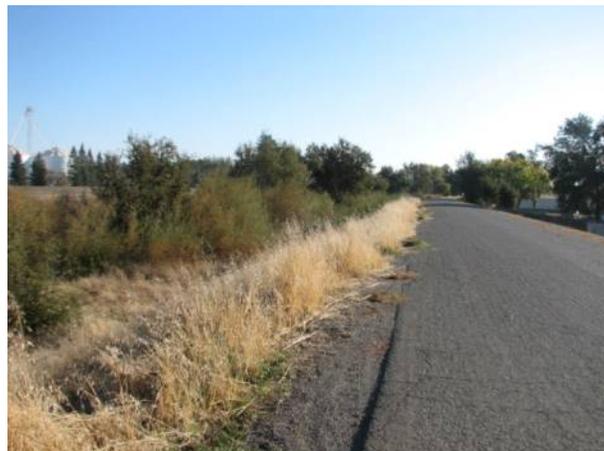
Levee Mile Report Line	12
Start Levee Mile	0.35
End Levee Mile	0.50
Location	Water Side
Category	Earthen Levee
Item	Vegetation
Tall vegetation block visibility on the waterside. Fall 2013	
johngw_f_20131028_257.JPG

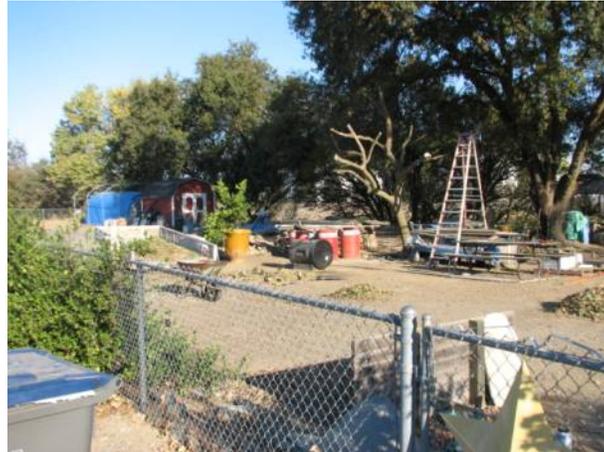
Levee Mile Report Line	14
Start Levee Mile	0.50
End Levee Mile	0.55
Location	Water Side
Category	Earthen Levee
Item	Encroachments

Material blocking visibility on the waterside of the levee. Fall 2013

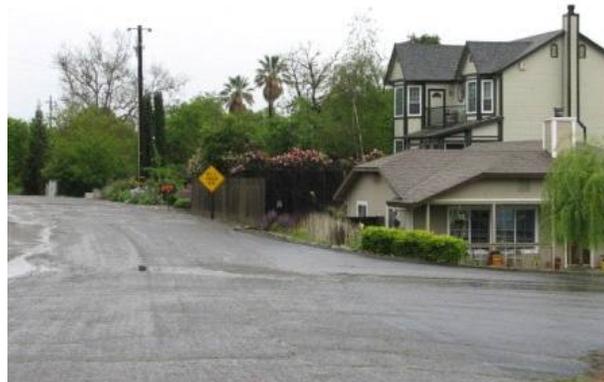
Levee Mile Report Line	15
Start Levee Mile	0.51
End Levee Mile	0.57
Location	Land Side
Category	Earthen Levee
Item	Encroachments

Houses on the landside of the levee. Fall 2013

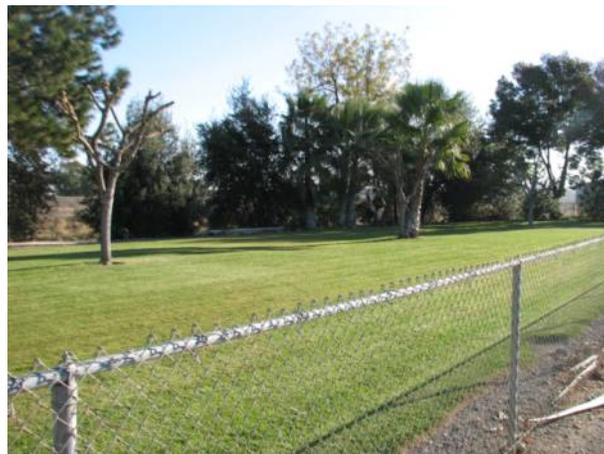
Levee Mile Report Line	16
Start Levee Mile	0.55
End Levee Mile	0.57
Location	Water Side
Category	Earthen Levee
Item	Vegetation

The lawn area is on the levee waterside and crown. Fall 2013

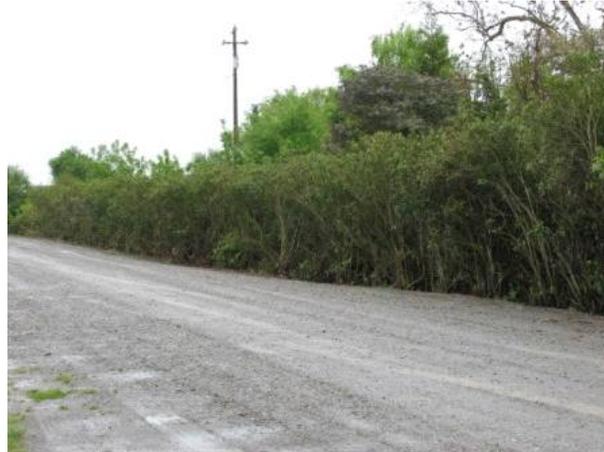
Oleanders along the shoulder.

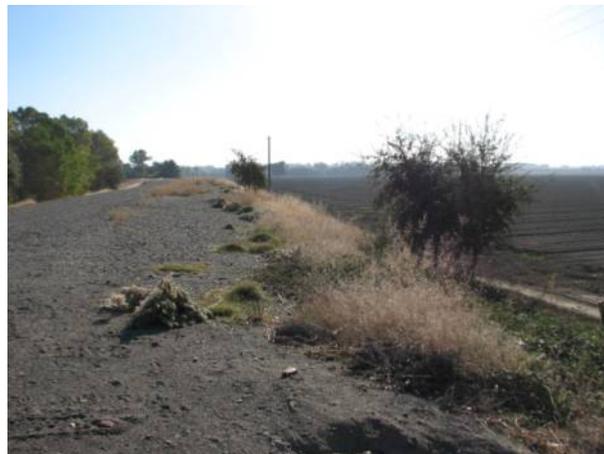
Levee Mile Report Line	21
Start Levee Mile	0.72
End Levee Mile	5.90
Location	Land Side
Category	Earthen Levee
Item	Vegetation
Tall grasses partially blocks visibility. Fall 2013	
johngw_f_20131028_263.JPG

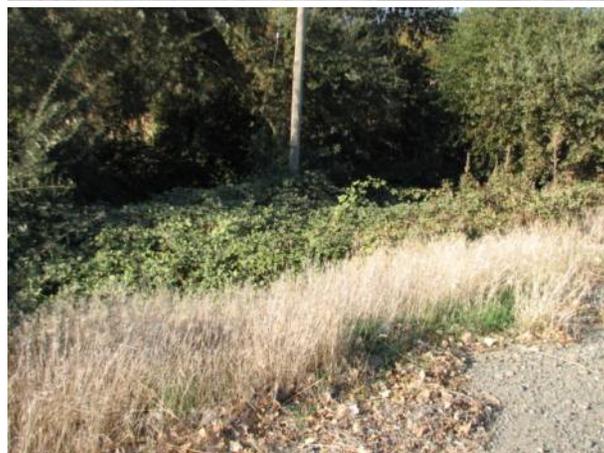
Levee Mile Report Line	22
Start Levee Mile	0.72
End Levee Mile	0.72
Location	Land Side
Category	Earthen Levee
Item	Vegetation
The berries block visibility of the levee slope. Fall 2013	
johngw_f_20131028_261.JPG

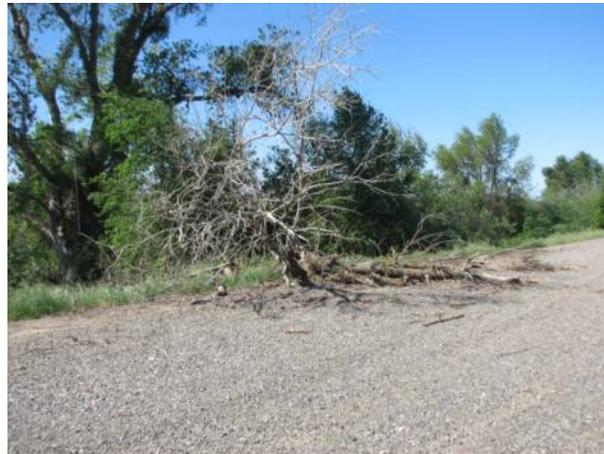
Levee Mile Report Line	24
Start Levee Mile	1.03
End Levee Mile	1.03
Location	Land Side
Category	Earthen Levee
Item	Trim / Thin Trees
A tree has fallen on the levee slope and crown. Spring 2013	
johngw_f_20131021_056.JPG

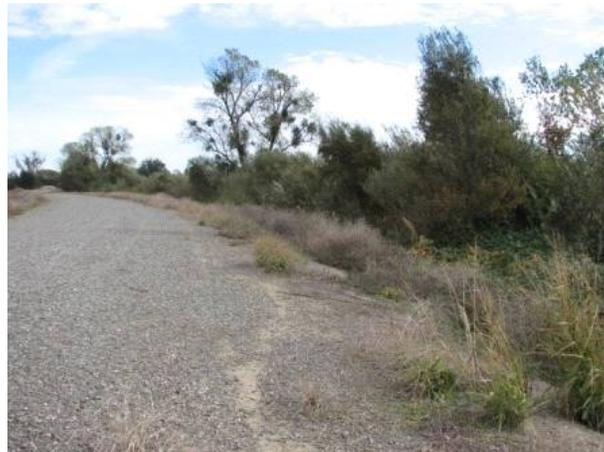
Levee Mile Report Line	25
Start Levee Mile	1.18
End Levee Mile	1.34
Location	Land Side
Category	Earthen Levee
Item	Vegetation
The vegetation blocks the view of the levee slope. Fall 2011	
johngw_f_20131021_035.jpg

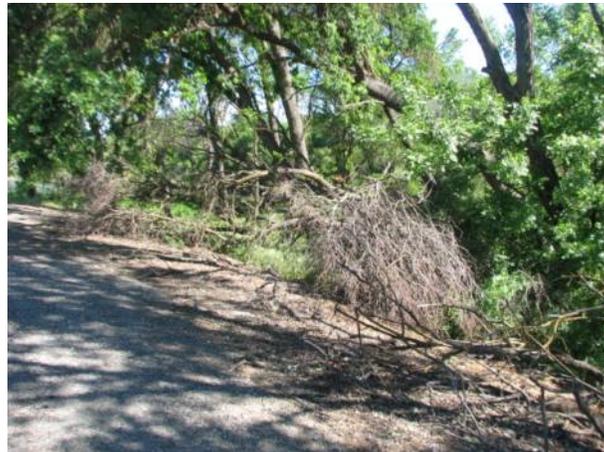
Levee Mile Report Line	27
Start Levee Mile	1.98
End Levee Mile	1.98
Location	Water Side
Category	Earthen Levee
Item	Encroachments
Branches and small trees have fallen on the levee slope. Spring 2013	
johngw_f_20131021_057.JPG

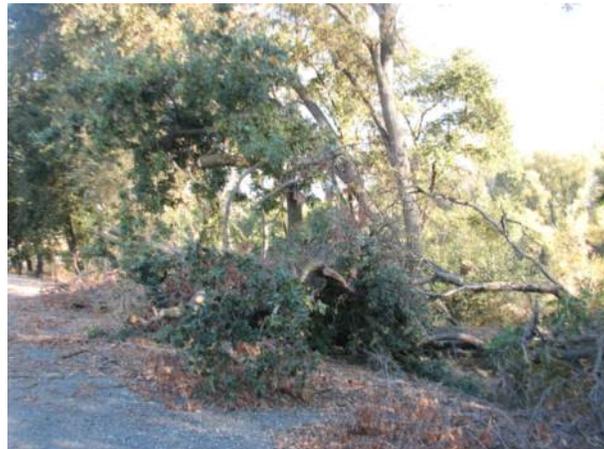
Levee Mile Report Line	27
Start Levee Mile	1.98
End Levee Mile	1.98
Location	Water Side
Category	Earthen Levee
Item	Encroachments
A tree has fallen on the waterside levee slope and shoulder. Fall 2013	
johngw_f_20131028_265.JPG

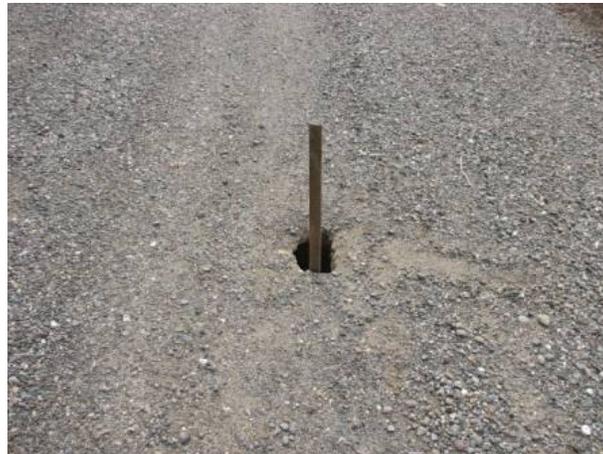
Levee Mile Report Line	29
Start Levee Mile	2.07
End Levee Mile	2.07
Location	Crown
Category	Earthen Levee
Item	Animal Control
A rodent hole in the crown of the levee. Fall 2011	
johngw_f_20131021_060.jpg

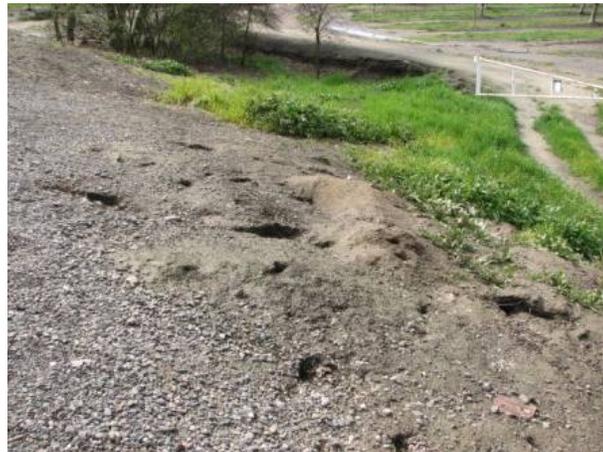
Levee Mile Report Line	30
Start Levee Mile	2.18
End Levee Mile	2.18
Location	Land Side
Category	Earthen Levee
Item	Animal Control
There are multiple rodent holes but no visible rodents. Need to backfill and compact.	
johngw_f_20131021_020.jpg

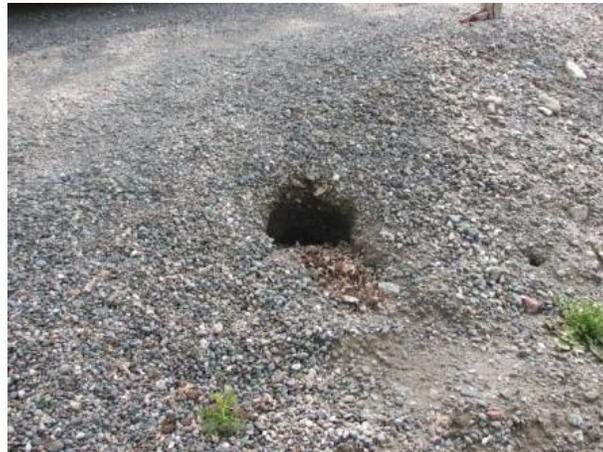
Levee Mile Report Line	32
Start Levee Mile	2.22
End Levee Mile	2.22
Location	Land Side
Category	Earthen Levee
Item	Animal Control
A rodent hole needs to be backfilled and compacted.	
johngw_f_20131021_048.jpg

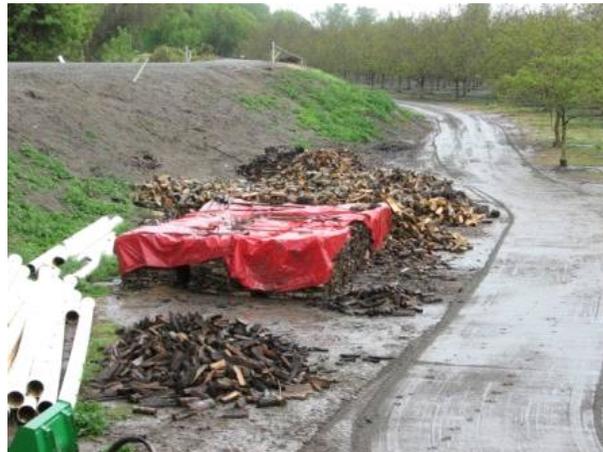
Levee Mile Report Line	33
Start Levee Mile	2.24
End Levee Mile	2.24
Location	Land Side
Category	Earthen Levee
Item	Encroachments
Firewood stacked up.	
johngw_f_20131021_052.jpg

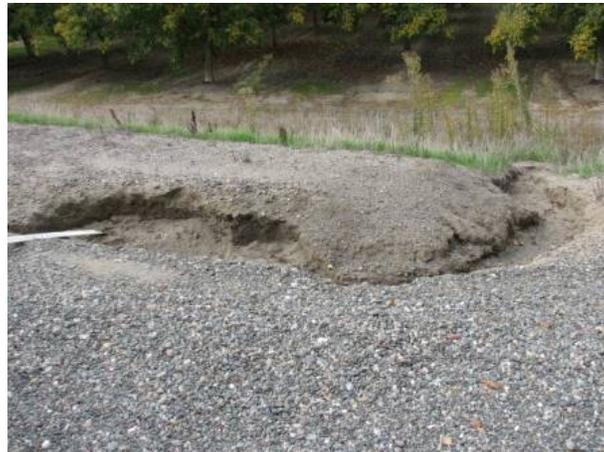
Levee Mile Report Line	37
Start Levee Mile	2.72
End Levee Mile	2.72
Location	Land Side
Category	Earthen Levee
Item	Erosion / Bank Caving
Eroision caused by a build up of water then running off the slope. Fall 2011	
johngw_f_20131021_061.jpg

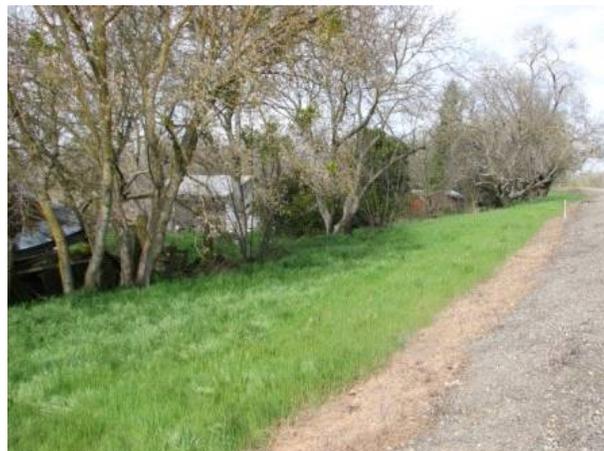
Levee Mile Report Line	40
Start Levee Mile	3.12
End Levee Mile	3.19
Location	Land Side
Category	Earthen Levee
Item	Encroachments
The buildings are encroaching into the levee slope.	
johngw_f_20131021_026.jpg

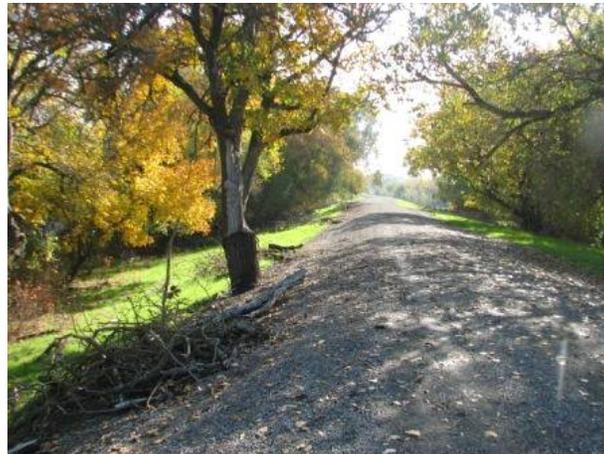
Levee Mile Report Line	41
Start Levee Mile	3.13
End Levee Mile	3.38
Location	Water Side
Category	Earthen Levee
Item	Encroachments
Piles of prunings are on the waterside slope. Fall 2012	
johngw_f_20131021_045.jpg

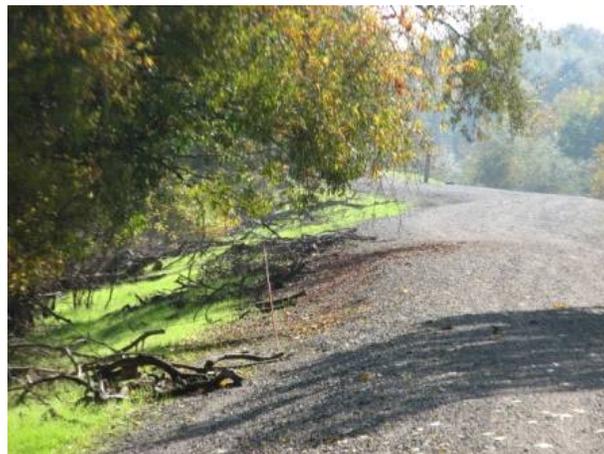
Levee Mile Report Line	41
Start Levee Mile	3.13
End Levee Mile	3.38
Location	Water Side
Category	Earthen Levee
Item	Encroachments
Many piles are on the slope. Fall 2012.	
johngw_f_20131021_046.jpg

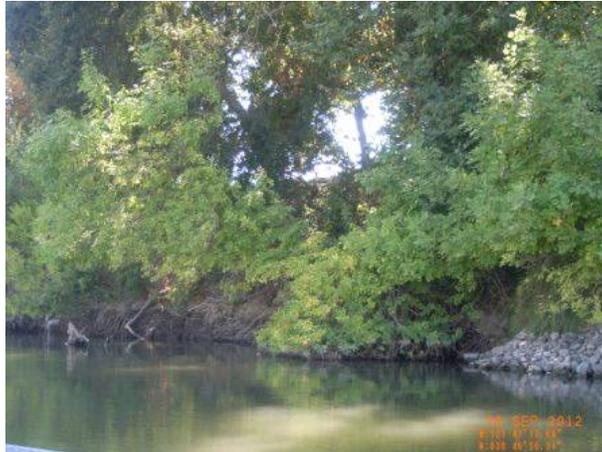
Levee Mile Report Line	43
Start Levee Mile	3.18
End Levee Mile	3.28
Location	Water Side
Category	Supplemental
Item	USACE Erosion Survey
USACE 2012 Photo #1	
USACE2013_SAC_86-9_R_1.jpg

LMIR No.	Levee Mile		Category	Item	Location	Rating	Action/Comment	GPS Latitude/Longitude		Issue No. Photo
	Start	End						Start	End	
43	3.18	3.28	Supplemental	USACE Erosion Survey	WS	M Ma	Inspector Comments: 2006 - Short section is into the levee toe, rest is near the levee toe. Mass failure and fluvial erosion of depositional material. Rock at the upstream and downstream ends. 2011 - Minor new erosion. 2012: No observed change. [2012 Site ID: SAC_86-9_R]	38.780407 ° -121.688238 °	38.779137 ° -121.687432 °	3 Y
DWR ID:										
44	3.25	3.25	Earthen Levee	Trim / Thin Trees	WS	M Ma	T3 : Trim and thin trees to allow visibility of the ground and room to flood fight. Inspector Comments: Dead tree broken during winter storms needs to be cleaned up.	38.780041 ° -121.688499 °	38.780041 ° -121.688499 °	15 Y
DWR ID: DWR_NA0022_01_s_2012_15										
45	3.31	3.31	Earthen Levee	Trim / Thin Trees	WS	M Ma	T3 : Trim and thin trees to allow visibility of the ground and room to flood fight. Inspector Comments: Fallen tree from winter storms, needs to be cleaned up.	38.779352 ° -121.688041 °	38.779352 ° -121.688041 °	16 Y

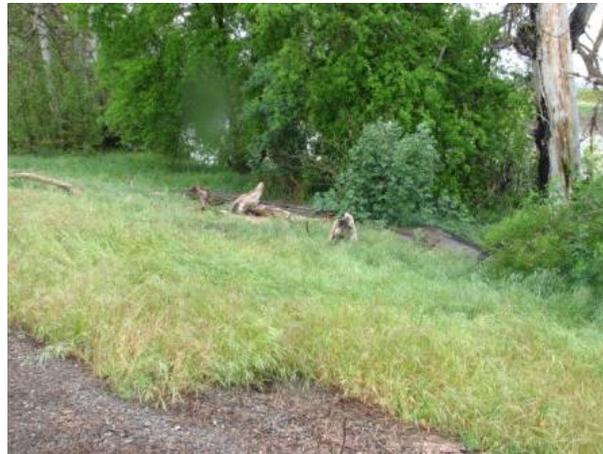
Levee Mile Report Line	44
Start Levee Mile	3.25
End Levee Mile	3.25
Location	Water Side
Category	Earthen Levee
Item	Trim / Thin Trees
Branches from dead trees, water side.	
johngw_f_20131021_028.jpg

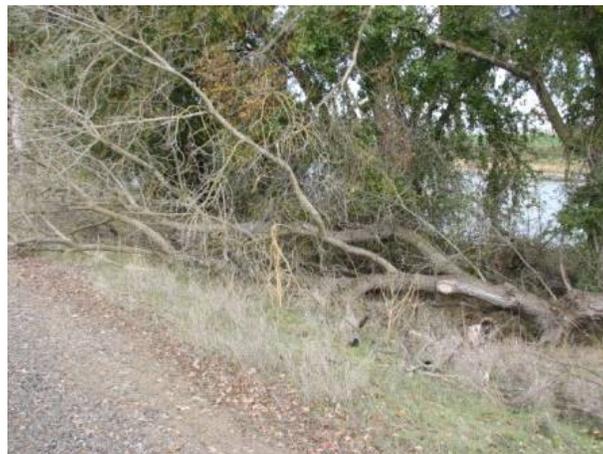
Levee Mile Report Line	45
Start Levee Mile	3.31
End Levee Mile	3.31
Location	Water Side
Category	Earthen Levee
Item	Trim / Thin Trees
A cottonwood tree has fallen over against the slope. Fall 2011	
johngw_f_20131021_029.jpg

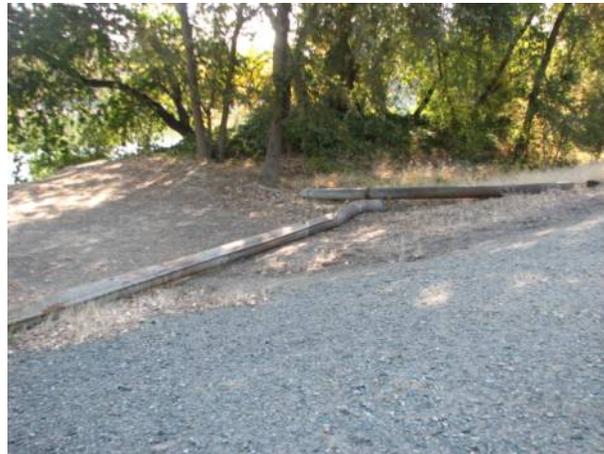
Levee Mile Report Line	46
Start Levee Mile	3.47
End Levee Mile	3.47
Location	Water Side
Category	Earthen Levee
Item	Encroachments
<p>Pipe has been laid on the waterside berm. Fall 2013</p> <p>johngw_f_20131028_267.JPG</p>

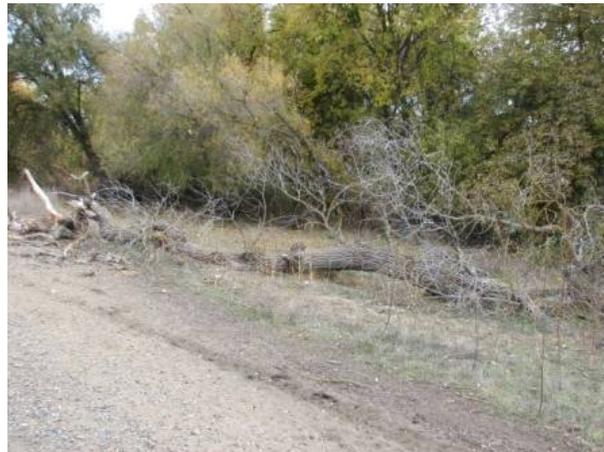
Levee Mile Report Line	47
Start Levee Mile	3.70
End Levee Mile	3.70
Location	Water Side
Category	Earthen Levee
Item	Encroachments
<p>Another tree has fallen on the waterside slope. Fall 2011</p> <p>johngw_f_20131021_062.jpg</p>
